DECLARATION OF JAY EGILMEZ

ADA ACCESSIBILITY INSPECTION REPORT

MULHOLLANDS 312 GRAND ST BROOKLYN, NY 11211

EXHIBIT "B"

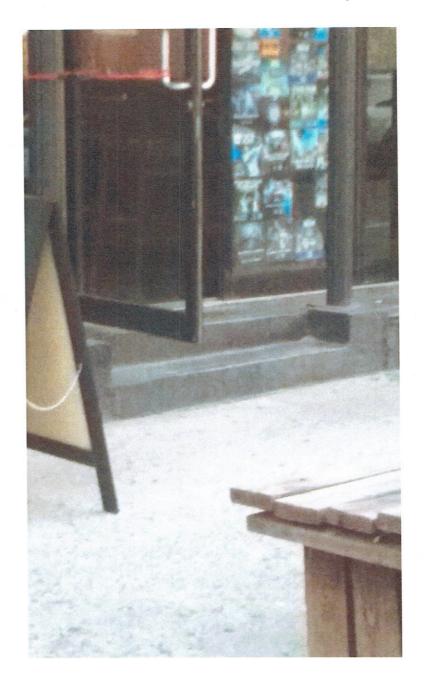
REQUIRED MINIMUM MANEUVERING CLEARANCE NOT PROVIDED AT ENTRANCE DOOR.

ADAAG 404.2.4 Maneuvering Clearances.

Minimum maneuvering clearances at doors and gates shall comply with 404.2.4. Maneuvering clearances shall extend the full width of the doorway and the required latch side or hinge side clearance.

- i. Entrance Level Landing: Defendant shall modify the entrance to the restaurant so that there is a level landing at the chosen accessible entrance, ensuring that the level landing is large enough to provide maneuvering clearances at the entrance door in compliance with Figure 404.2.4.1 of the 2010 Standards, ensuring that the new landing does not exceed a slope of 1:48 (1/4"/ft.) (2.083%) in any direction; and providing edge protection if there is a drop-off in compliance with ADAAG §404.2.4.

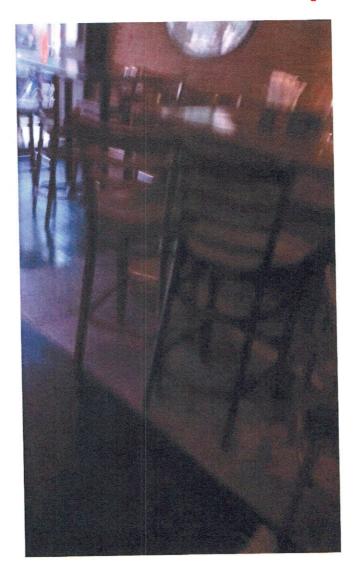
INACCESSIBLE DINING TABLES LOCATED AT INTERIOR DINING AREA.

NON-COMPLIANT HEIGHT OF INTERIOR DINING TABLES EXCEED MAXIMUM HEIGHT REQUIREMENT.

ADAAG 226 Dining Surfaces and Work Surfaces ADAAG 226.1 General.

Where dining surfaces are provided for the consumption of food or drink, at least 5 percent of the seating spaces and standing spaces at the dining surfaces shall comply with 902.

ADAAG 902.3 Height.

The tops of dining surfaces and work surfaces shall be 28 inches (710 mm) minimum and 34 inches (865 mm) maximum above the finish floor or ground.

- iii. Accessible Seating: Defendant shall provide a minimum of 5% of accessible seating, ensuring that the accessible tables are a minimum 30" in width, have 27" of knee clearance and 17" of unobstructed depth in compliance with ADAAG §§206.1,306.3.2-3.5, and §902.2;

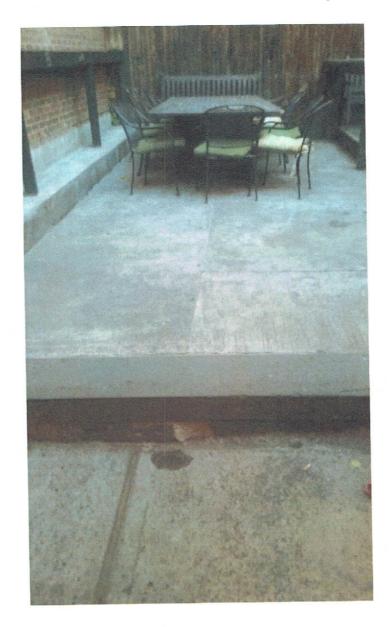
INACCESSIBLE TRAVEL PATH TO EXTERIOR DINING AREA.

A RISE IN FLOOR LEVEL IN THE FORM OF A RAISED PLATFORM EXISTS AT THE TRAVEL PATH TO EXTERIOR DINING AREA.

REQUIRED RAMP NOT PROVIDED.

ADAAG 303.4 Ramps.

Changes in level greater than ½ inch high shall be ramped, and shall comply with 405 or 406.
